# Trip to Sunshine Coast Queensland, September 2004 Visit to Schools

## Report No 2002-059-B No 7

**Project Name** Case Based Reasoning in Construction and Infrastructure Projects

**Date:** January 2005

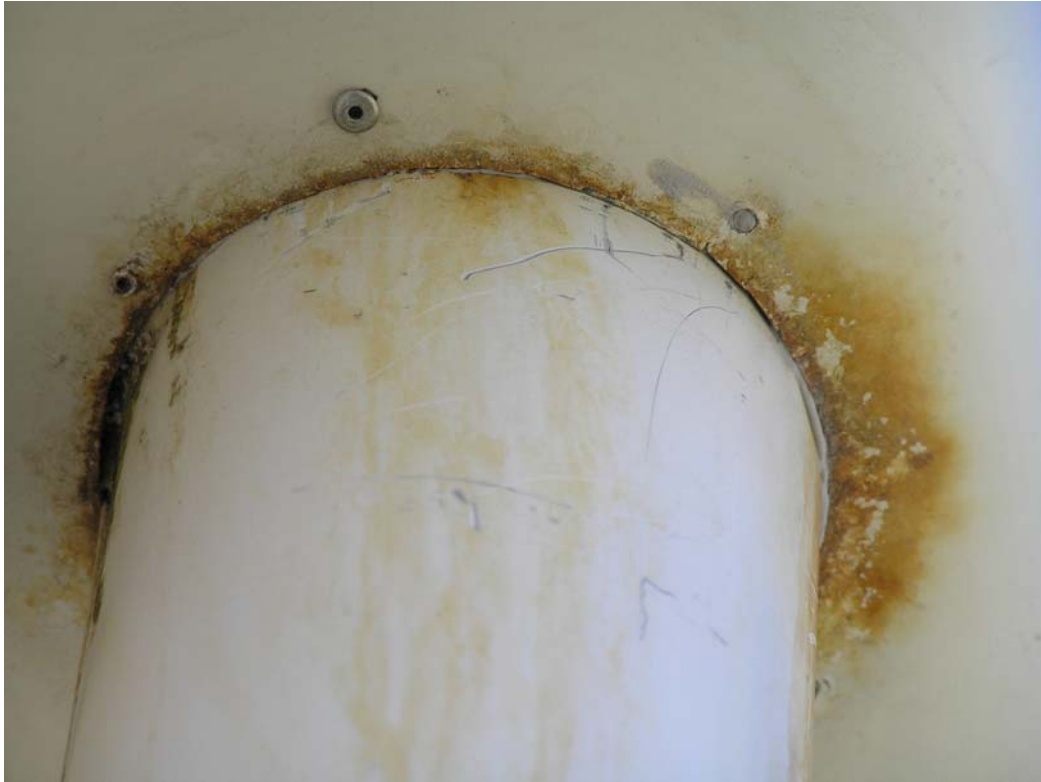
Figure 53 Close up of degradation of gutter at join, note pop rivets corroded away.

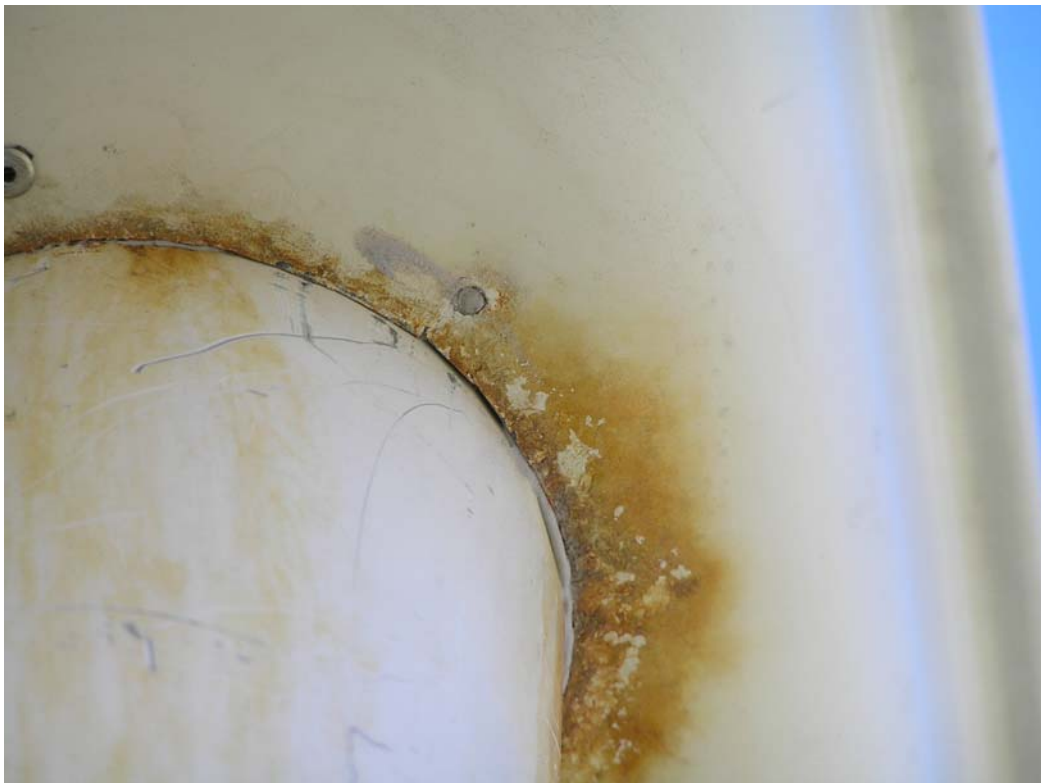
Figure 54 Close up of degradation of gutter at join, note pop rivets corroded away.

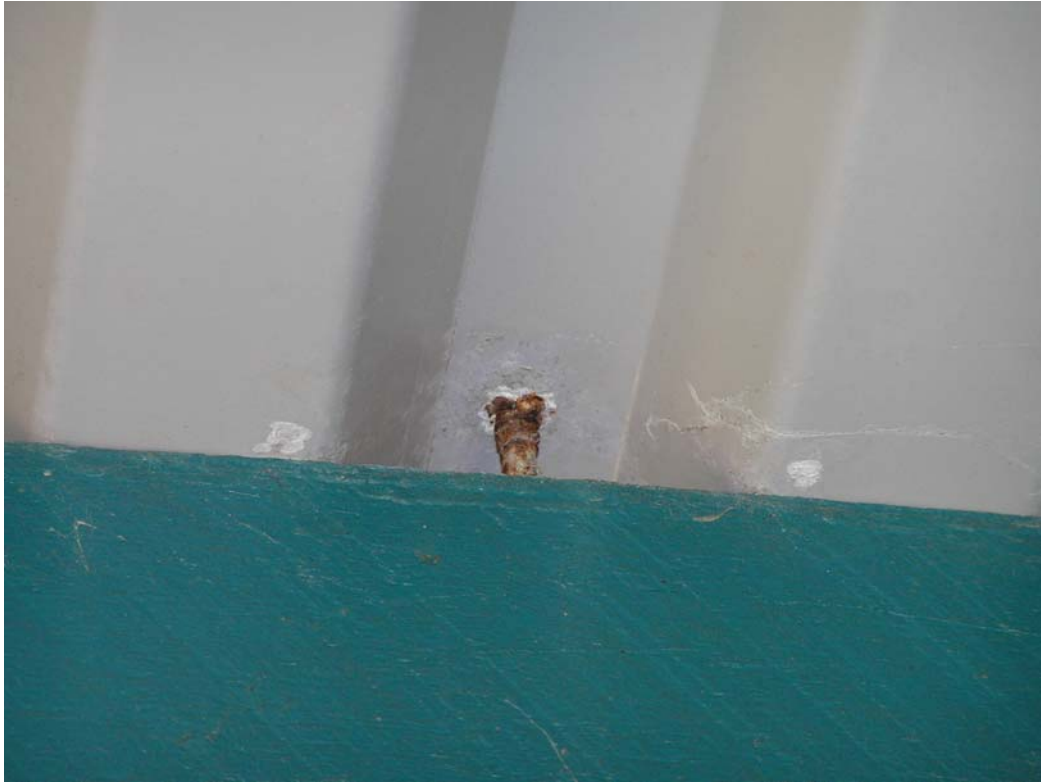
Figure 55 Corroded fastener under covered area, sheeting also showing undercutting.

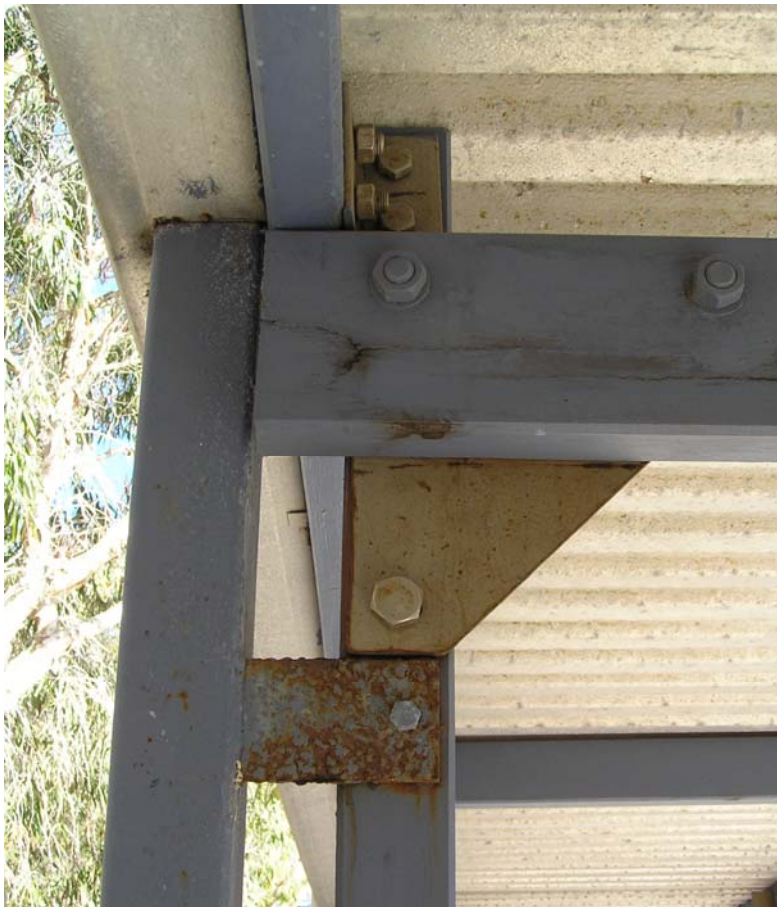
On some covered walkways square section steel was used as downpipes. It is assumed the steel was used as standard downpipes would be destroyed by the students. It can be seen in the following figures that the painted steel is corroding from the inside out.

Figure 66 Top of downpipe also showing rusting of bracket from downpipe to support and stainless steel plates on walkway beams.

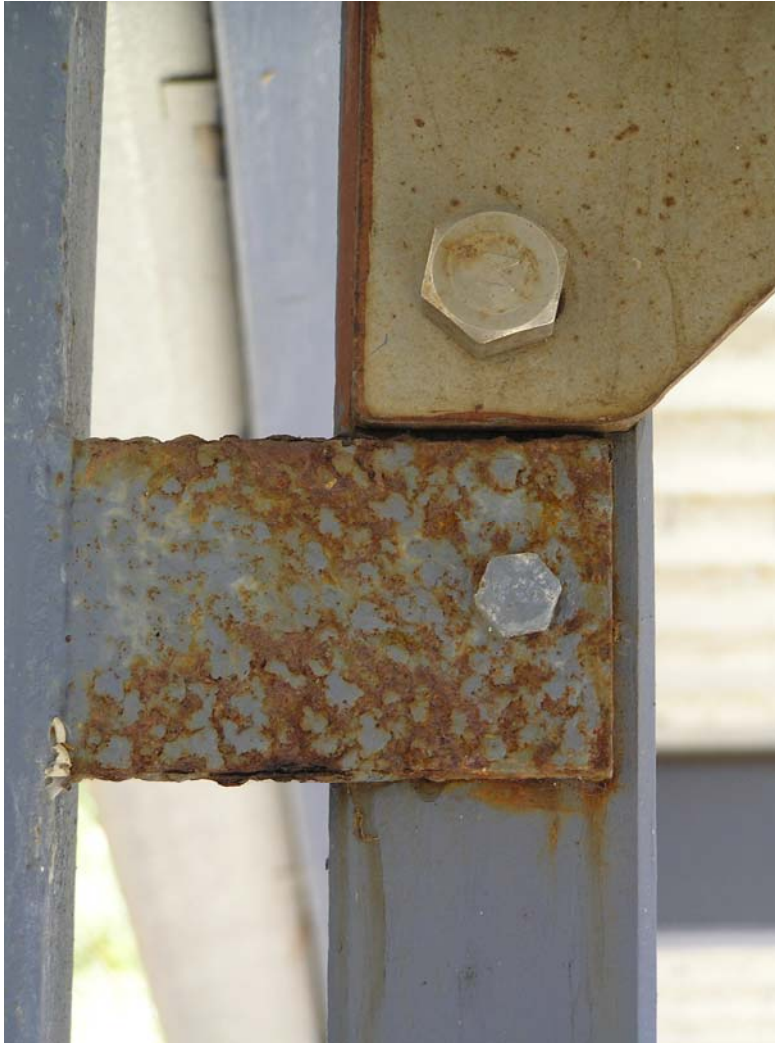
Figure 67 Close up of downpipe bracket and stainless steel connector plate.

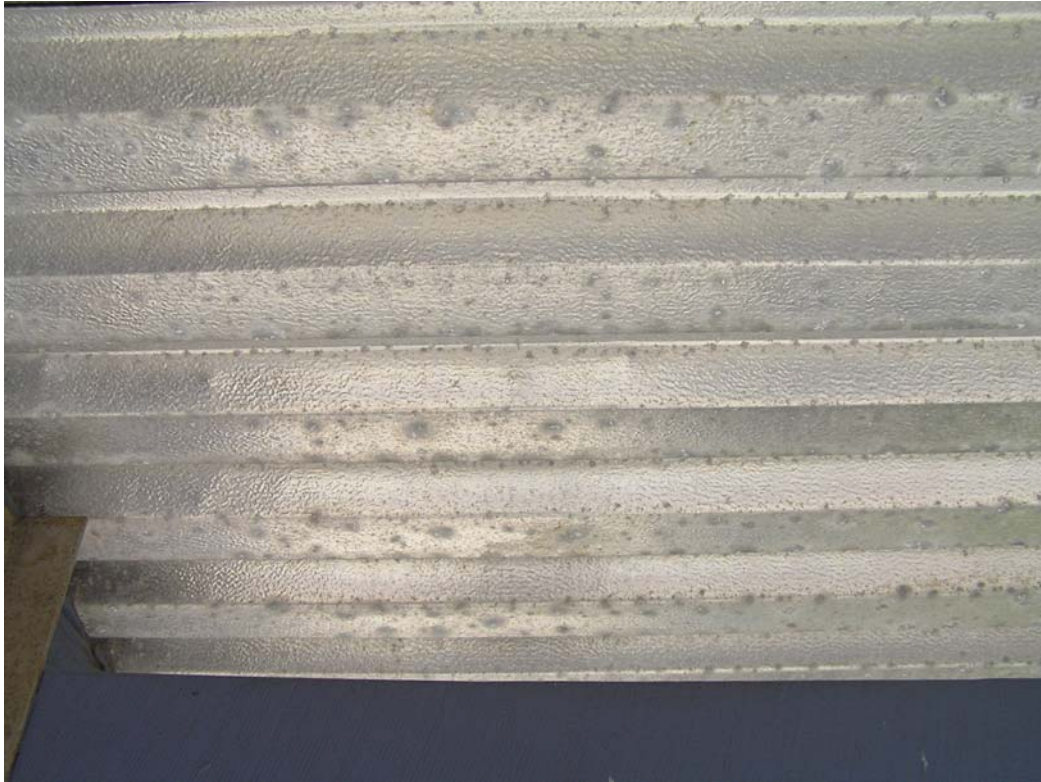
The aluminium sheeting used on the walkways looked ok on the exposed outer surface but underneath there was significant corrosion. It looked like galvanised fasteners were used to fasten the sheeting and these were corroded on the heads, some to 100% red rust. The shanks of all the fasteners were heavily corroded.

Figure 68 Underside of aluminium roof sheeting of covered walkway.

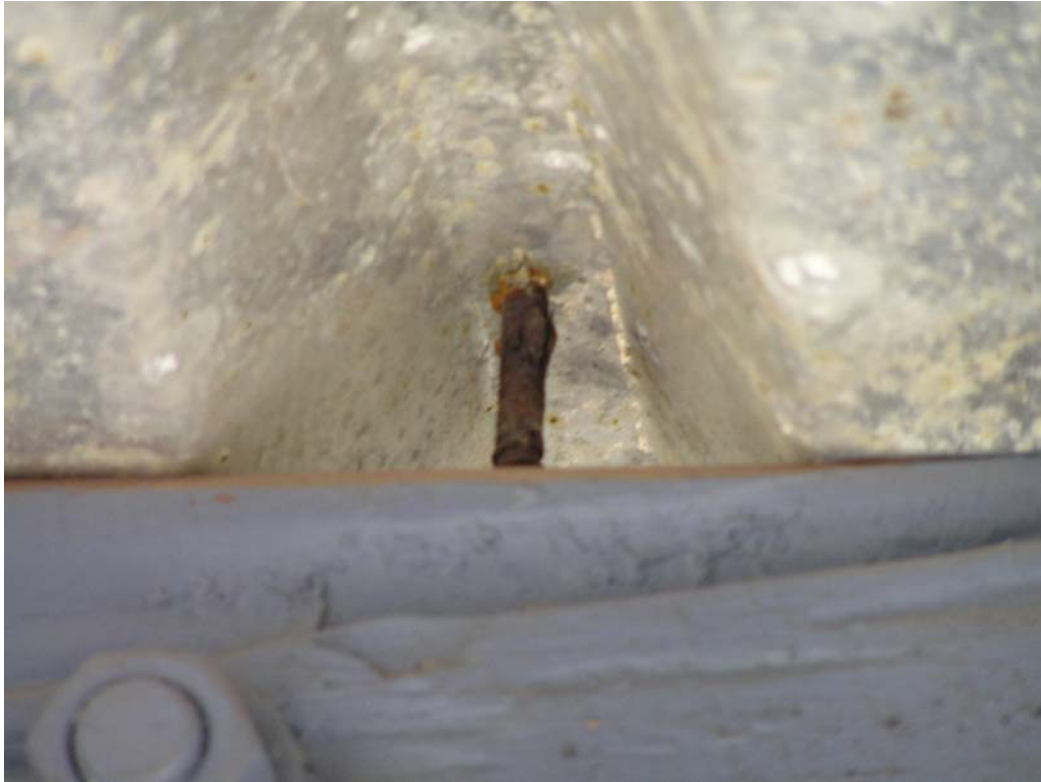
Figure 70 Heavily corroded fastener in sheeting of covered walkway.

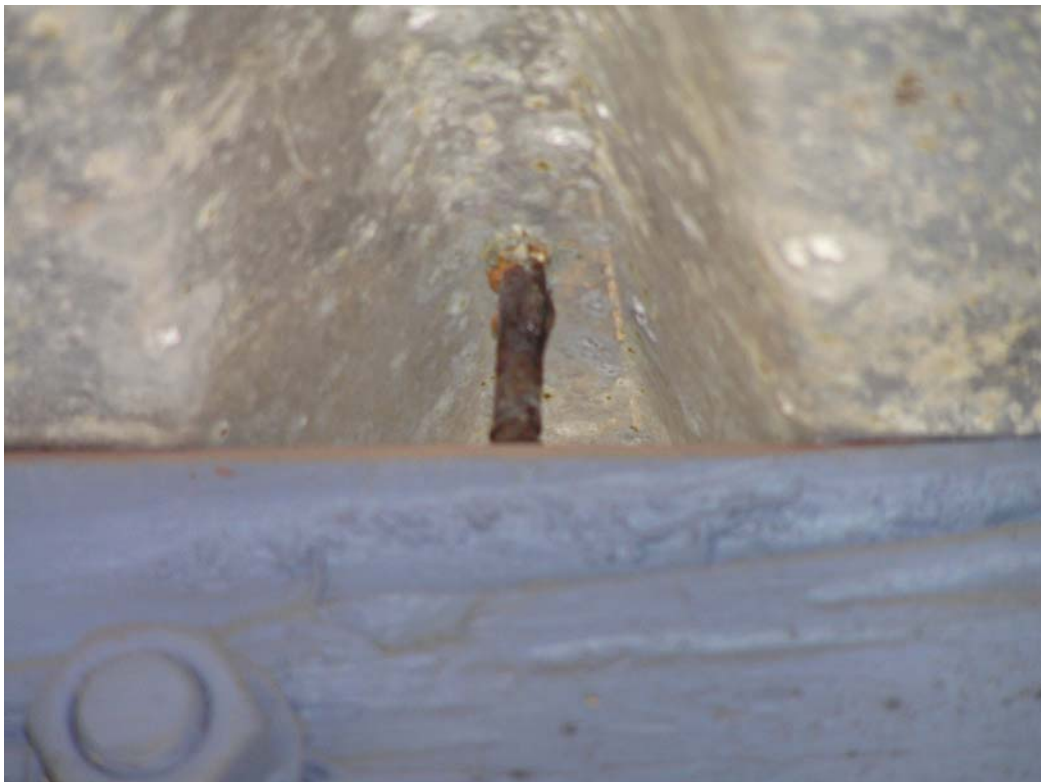
Figure 71 Heavily corroded fastener in sheeting of covered walkway.

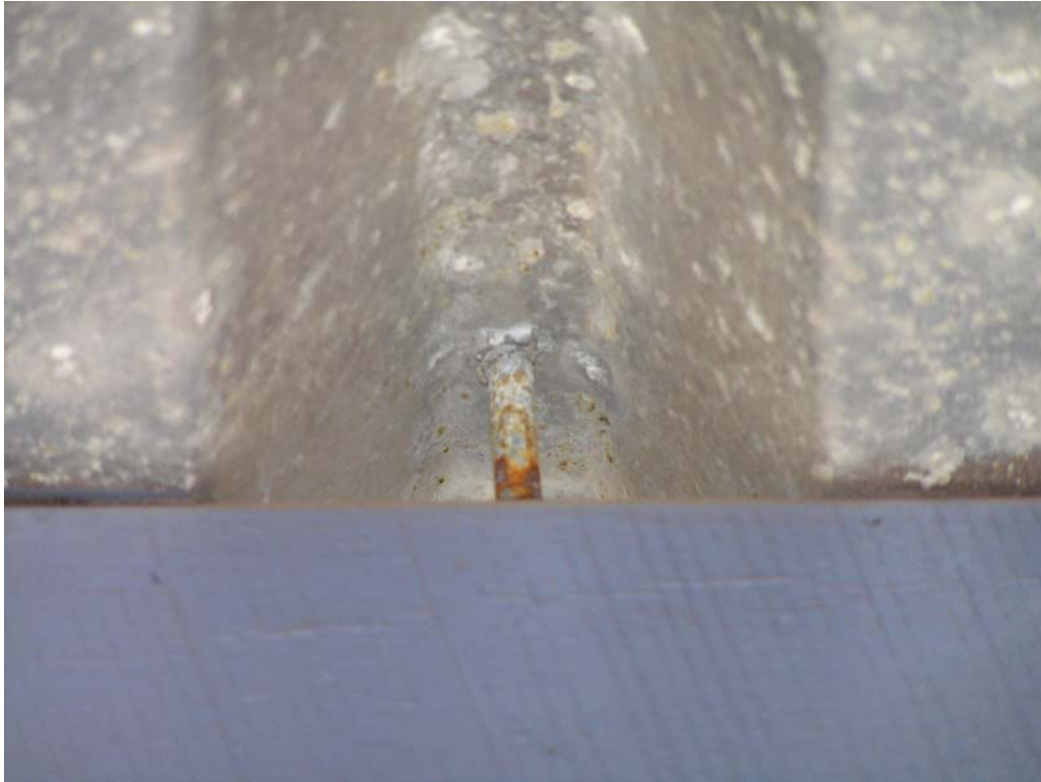
Figure 72 Heavily corroded fastener in sheeting of covered walkway.

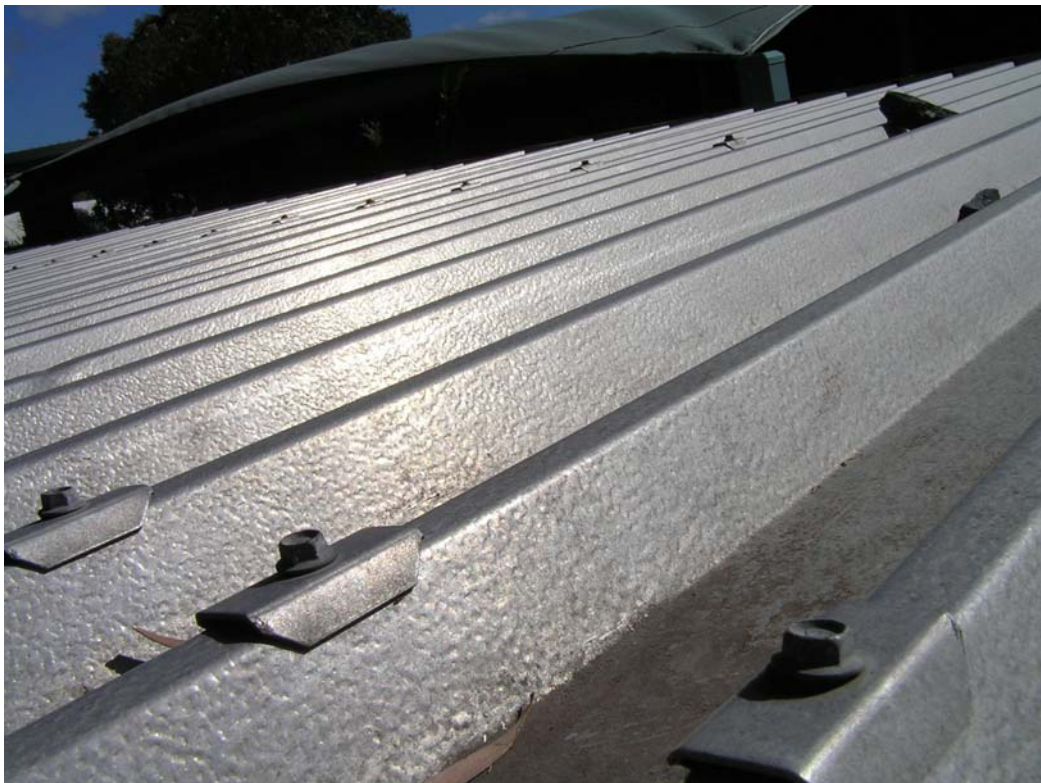
Figure 73 Exposed surface of aluminium walkway in good condition, note cyclone plates.

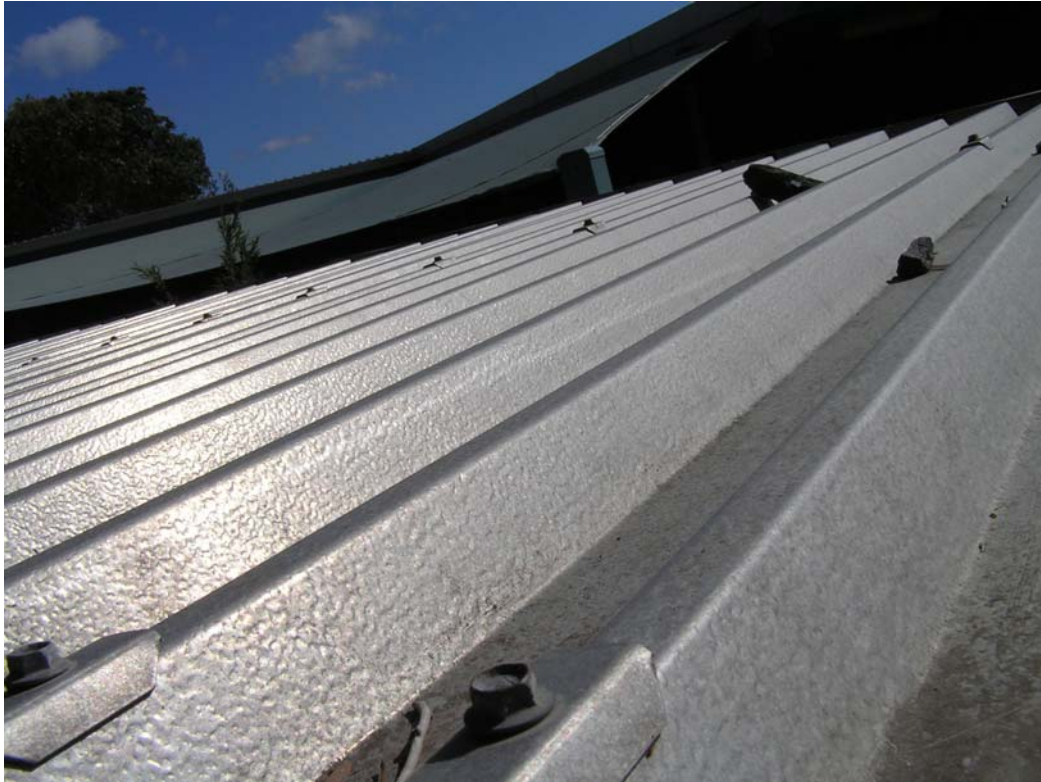
Figure 76 Exposed surface of aluminium walkway in good condition.

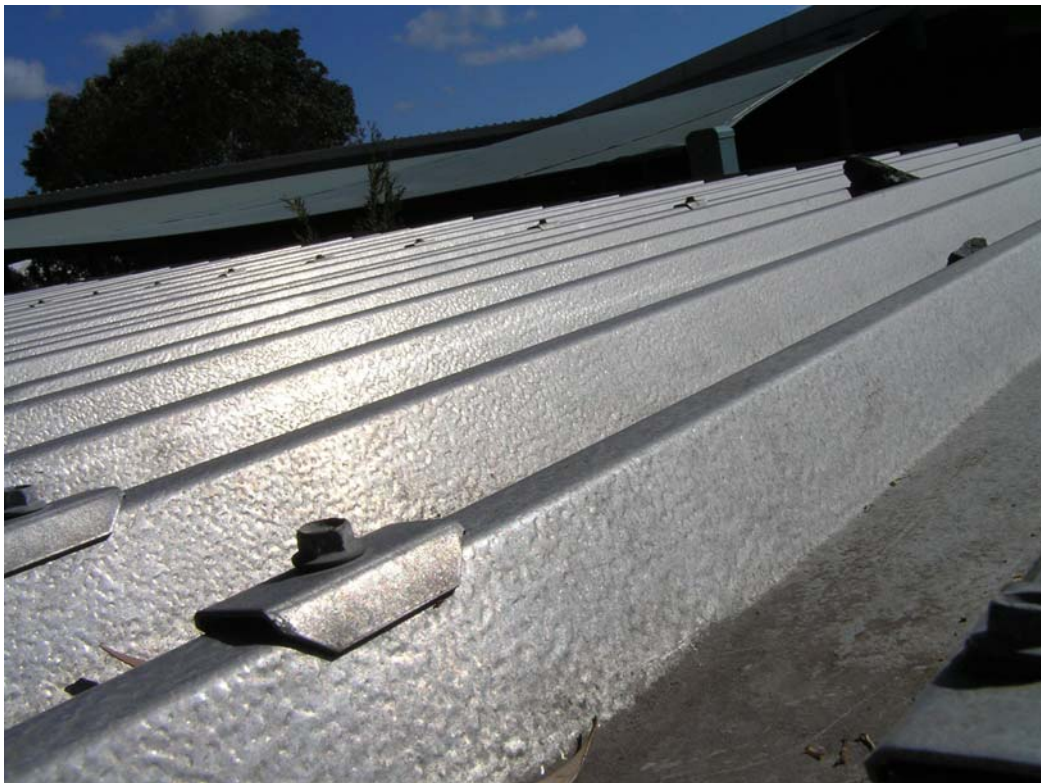
Figure 77 Exposed surface of aluminium walkway in good condition.

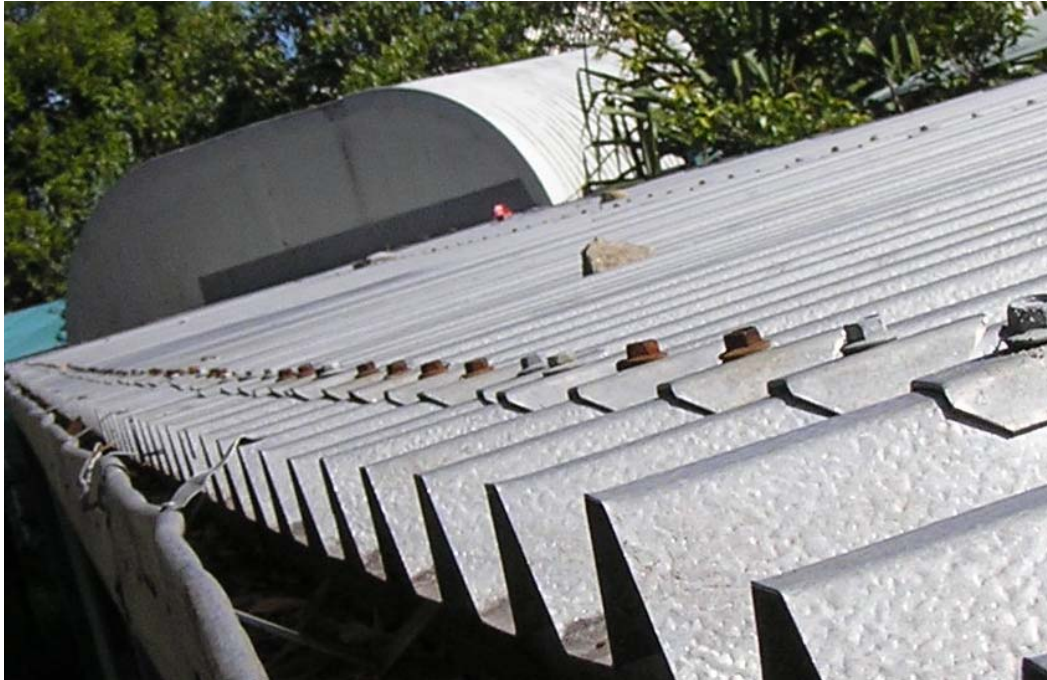
Figure 78 Close up of fasteners showing red rust and white corrosion product.

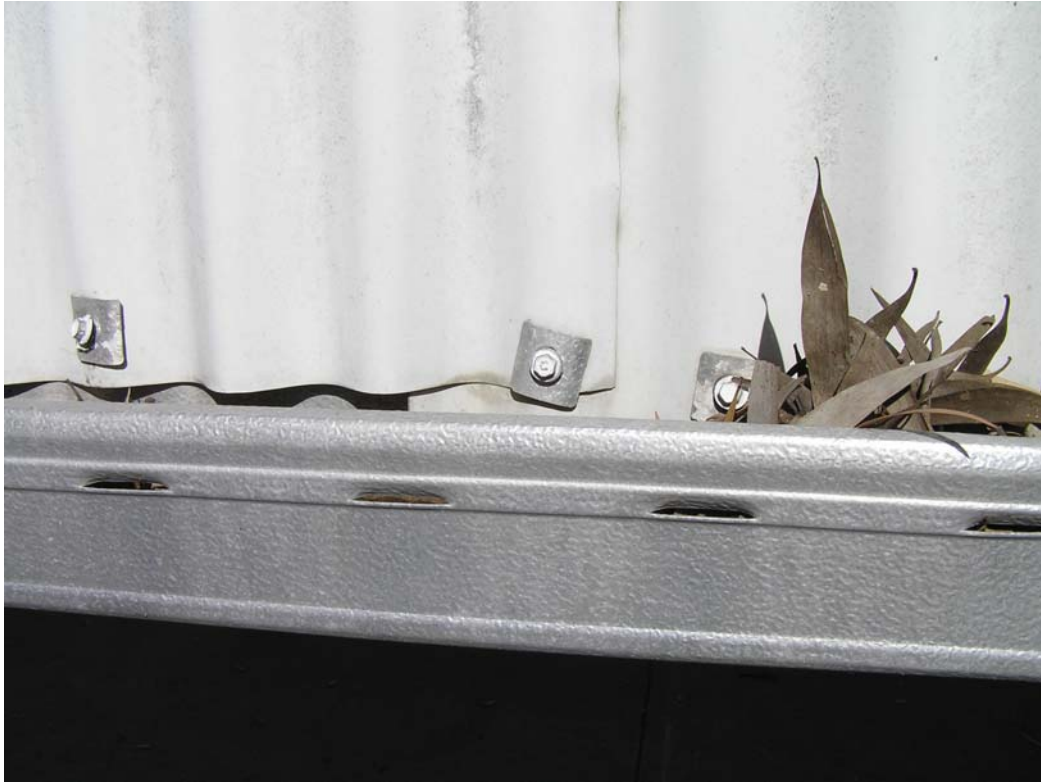
Figure 82 Colorbond walkway with aluminium gutters and stainless steel fasteners and aluminium cyclone plates.

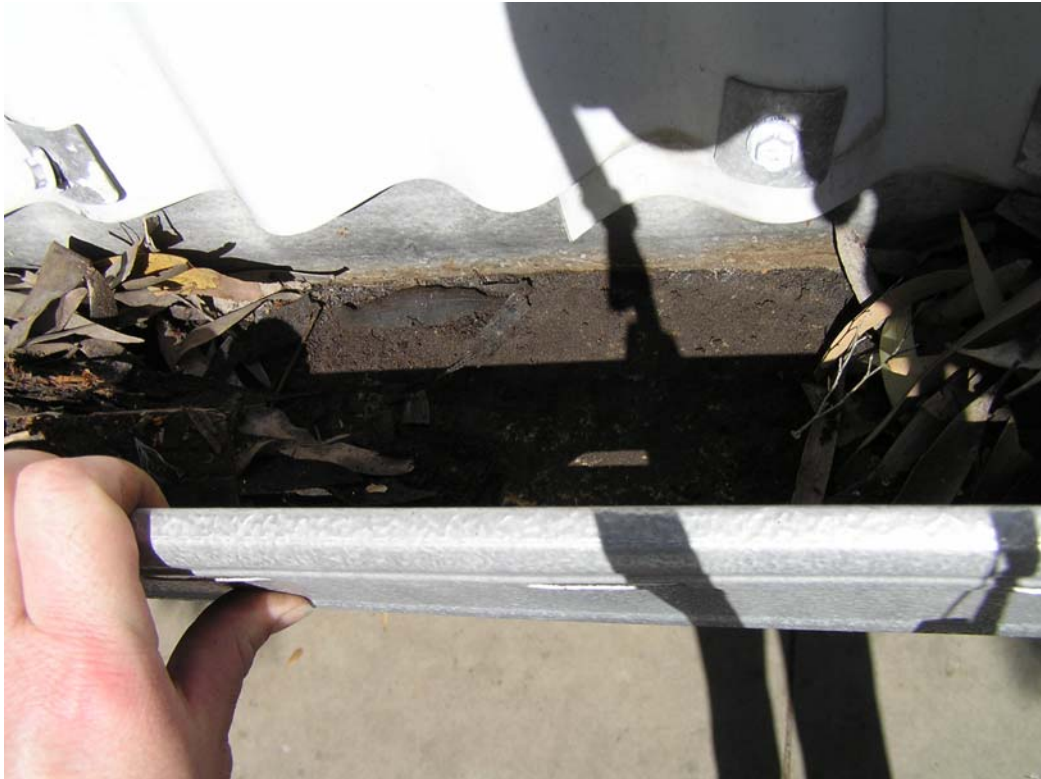
Figure 83 Inside gutters, although dirty, looked to be in OK condition.

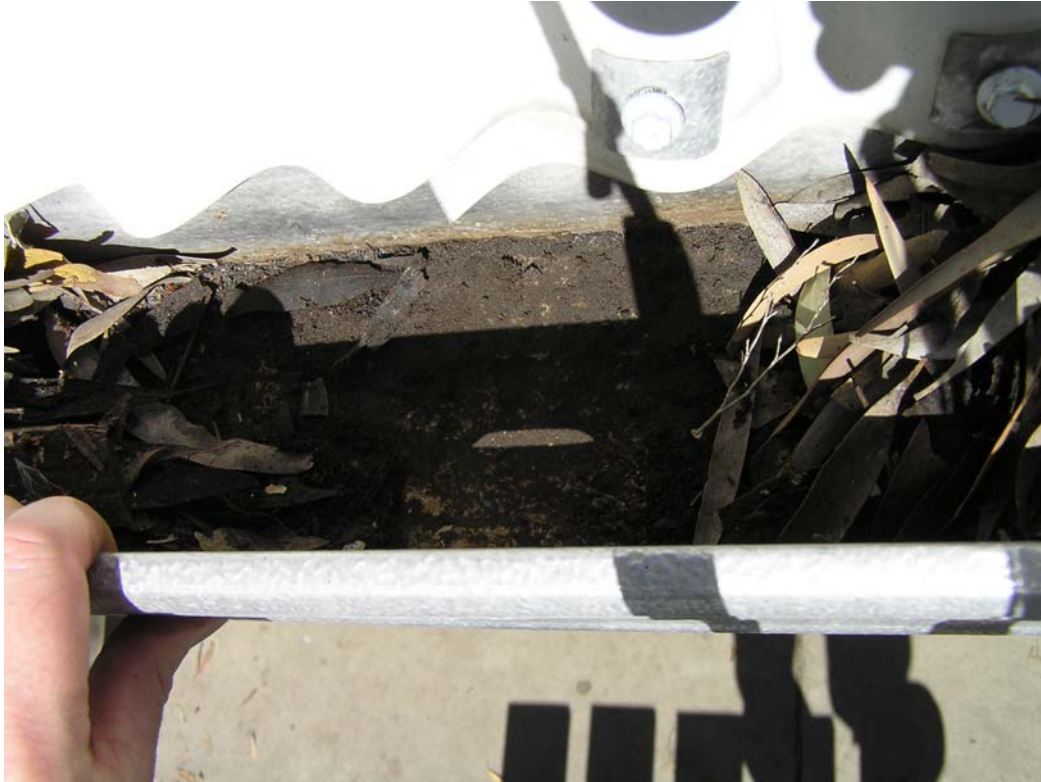
Figure 84 Inside gutters, although dirty, looked to be in OK condition.

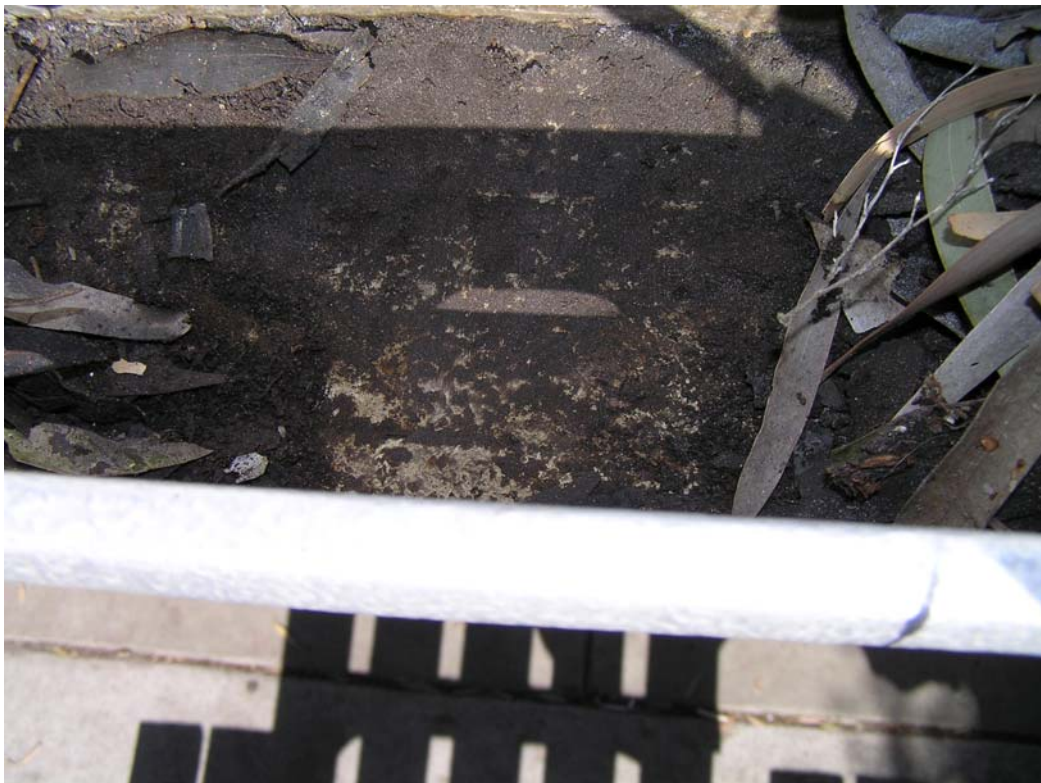
Figure 85 Inside gutters, although dirty, looked to be in OK condition.

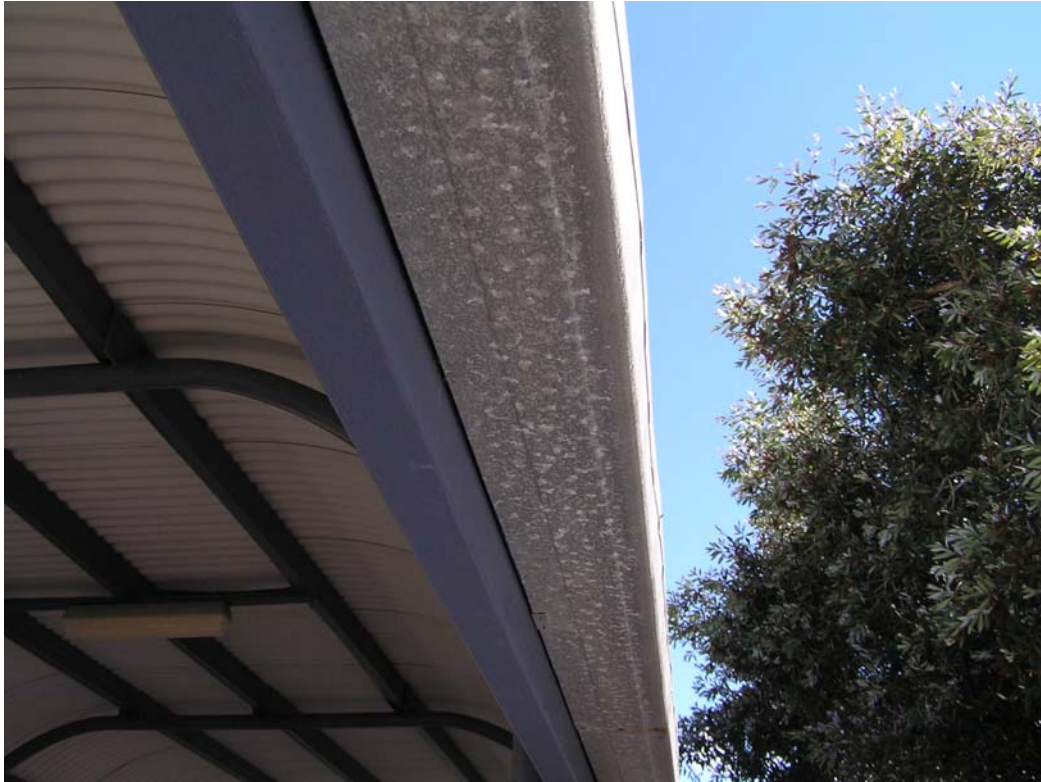
All the aluminium gutters showed corrosion on the underneath side, even on the colorbond walkways. As with the other schools where joins were made in the gutters significant deterioration had occurred.

Figure 86 Underside of all gutters were significantly corroded.

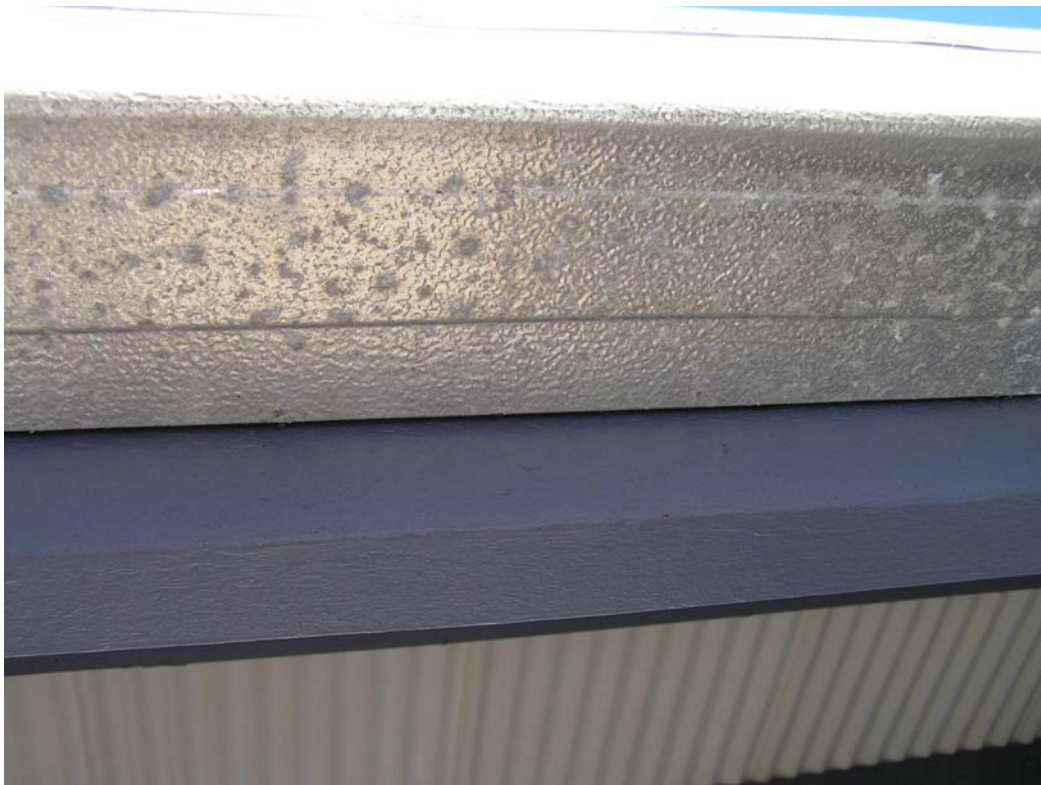
Figure 87 Underside of gutters.

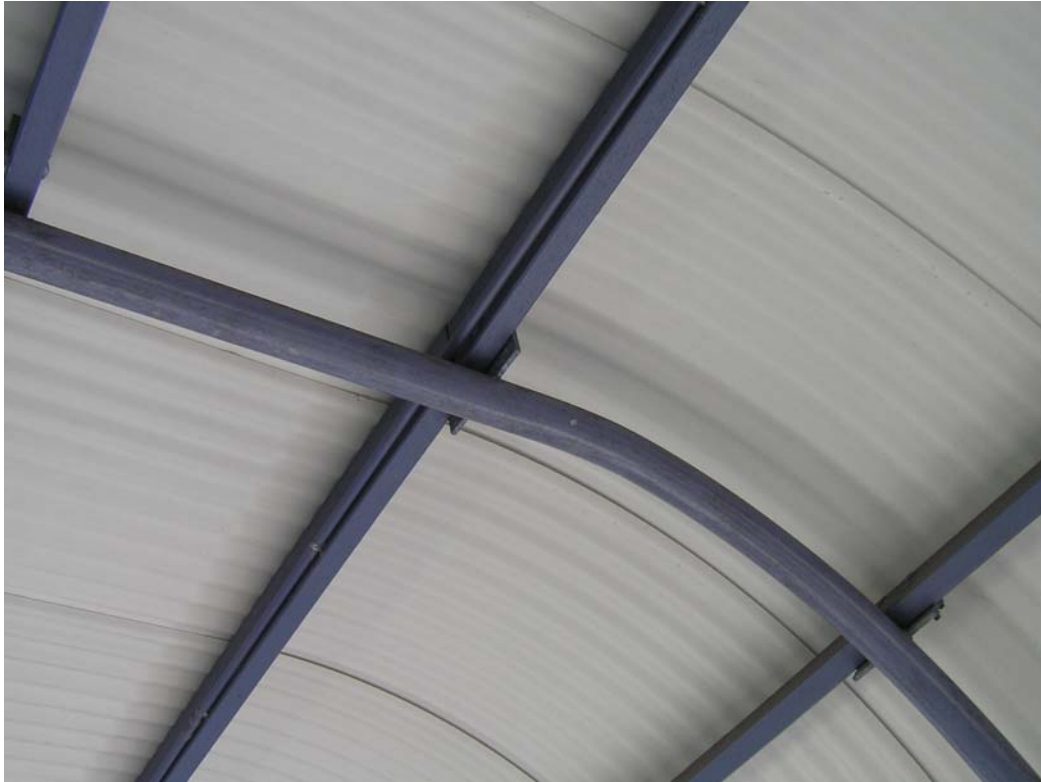
Figure 88 Underside of Colorbond walkways in good condition, some deterioration of painted steel supports.

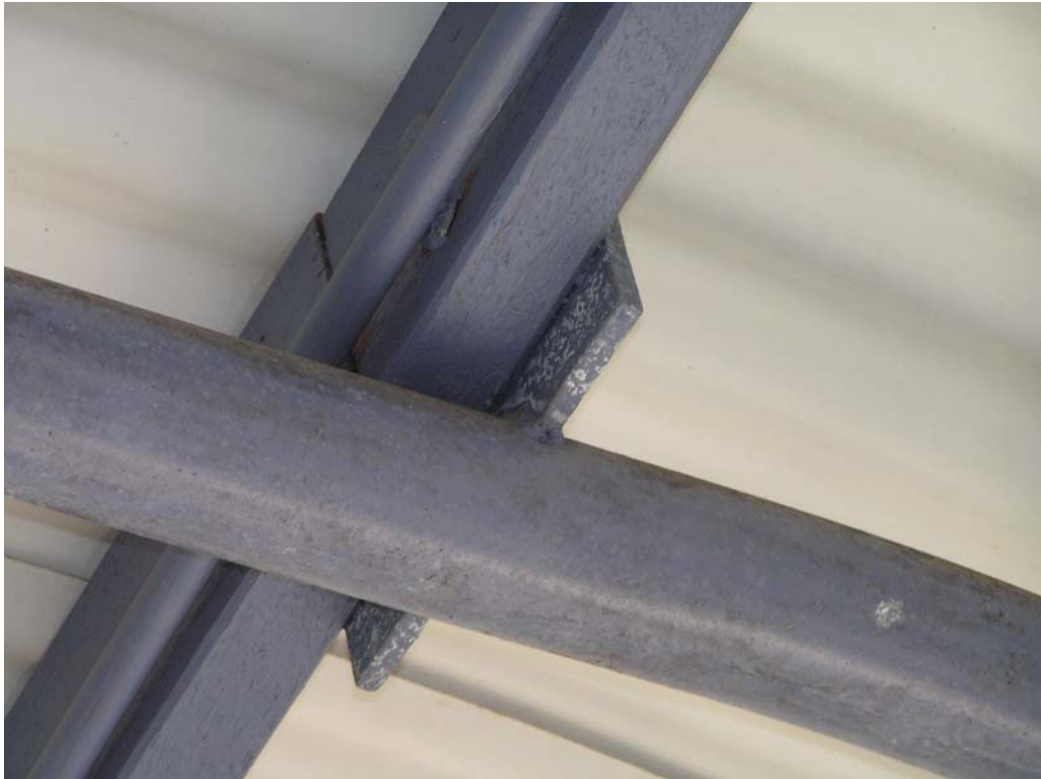
Figure 89 Close up of painted steel supports showing some deterioration of paint and some break through of rust and white corrosion product.

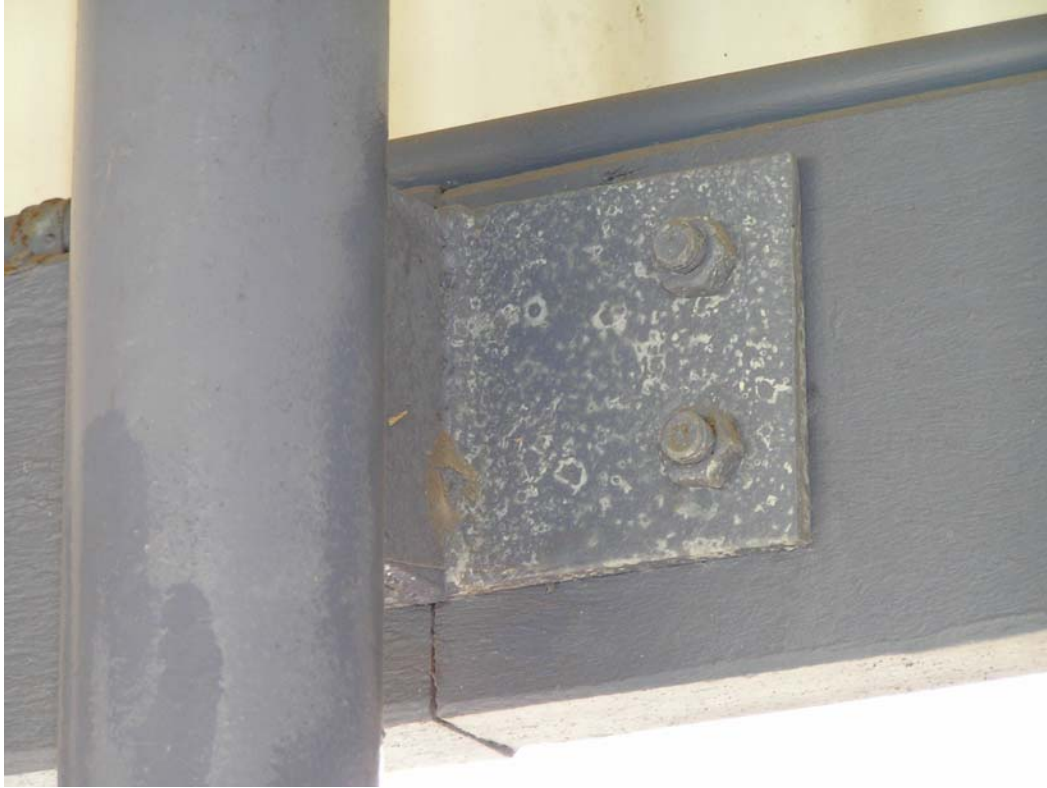
Figure 90 White corrosion product on painted steel brackets.

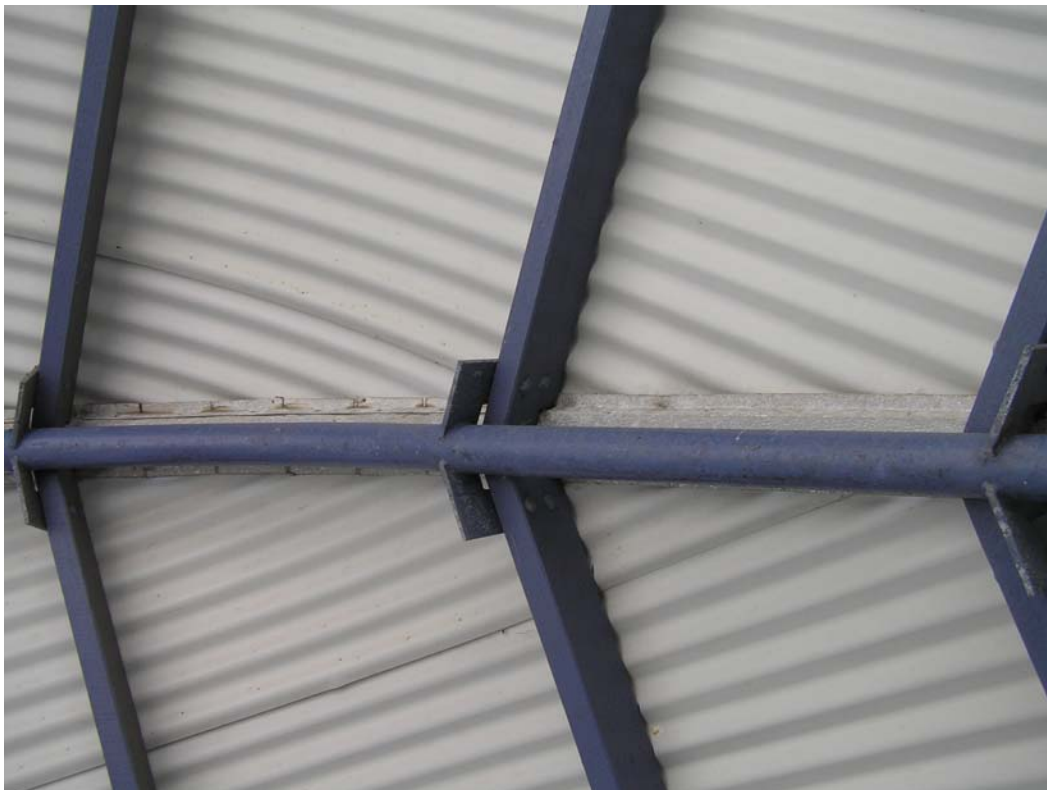
Figure 91 Joint between two walkways showing the used of galvanised flashing which has significant white corrosion product.

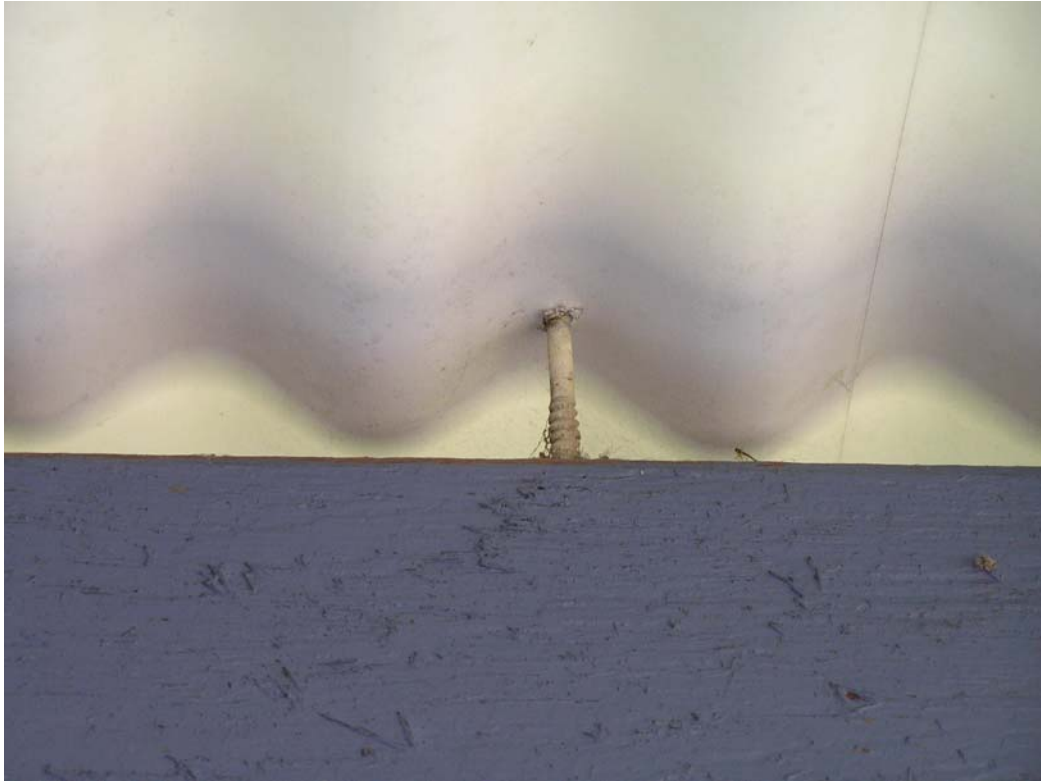
Figure 92 Shank of stainless steel fastener in Colorbond walkway, no deterioration.

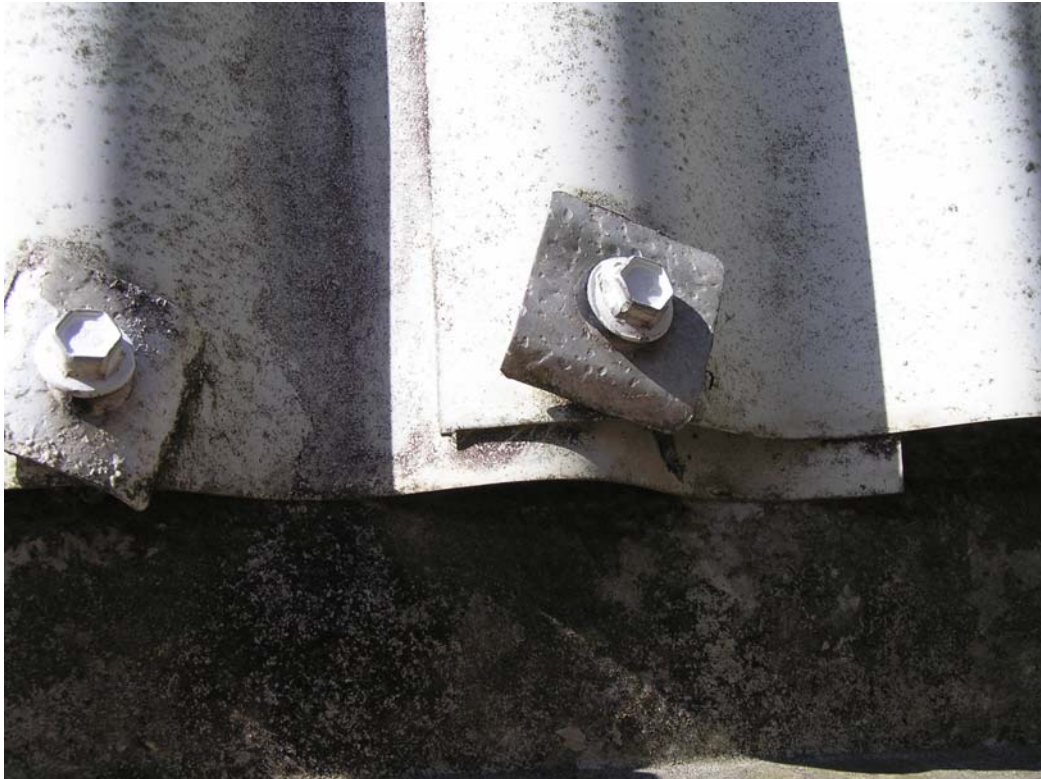
Figure 93 Colorbond sheeting and aluminium gutter showing significant growths.

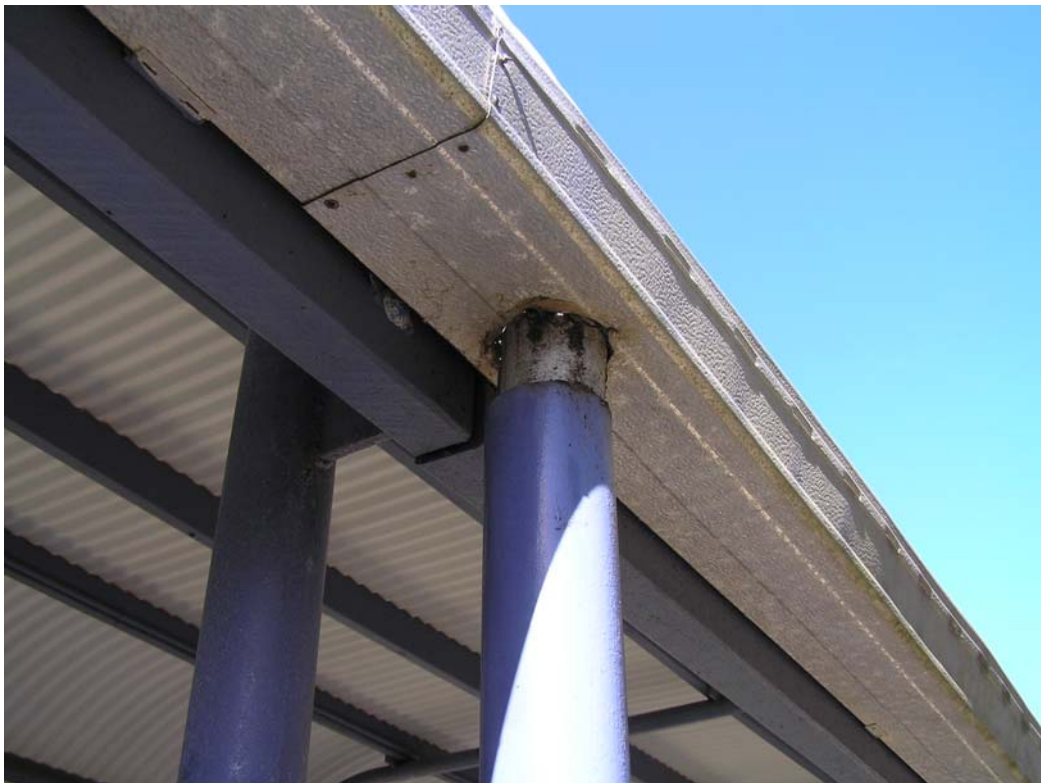
Figure 95 Deterioration around joint between gutter and downpipe (note loss of rivet heads).

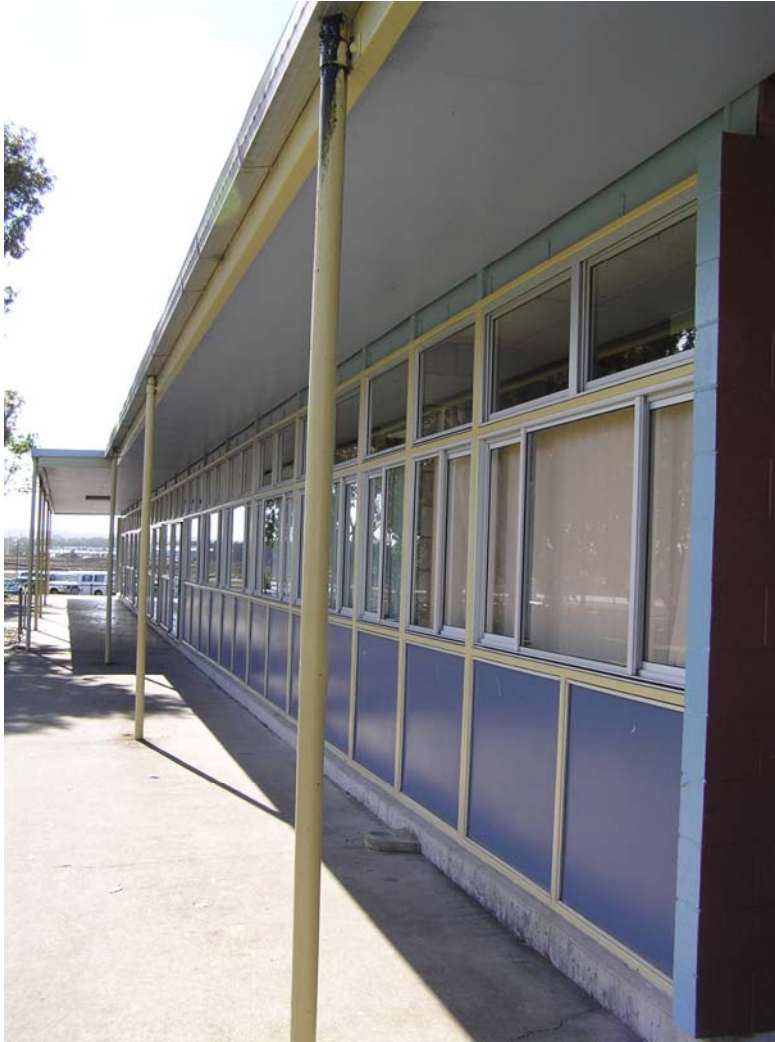
Another problem seen at this school is the use of structural downpipes. This is where as seen in the following figures the downpipe forms part of the structure holding up the eaves of the building. There is a steel U section around the edge of the eave with a piece of timber inside it. The U section is bolted to the downpipe. What seems to be happening is that the gutters, which are a fairly small diameter, block up. The water then overflows at the downpipe onto the U section and corrodes the U section and the timber is wet helping the corrosion. It was said that it costs \$80,000 to replace the steel U sections on one building.

Figure 96 Structural downpipes.
